## **Response of AES Puerto Rico LP to EPA's September 16, 2014 Water Compliance Inspection Report**

AES Puerto Rico LP ("AESPR") hereby submits this response to EPA's September 16, 2014 Water Compliance Inspection Report ("Inspection Report"). For ease of reference, AESPR will follow EPA's Findings of the Facility Walkthrough.

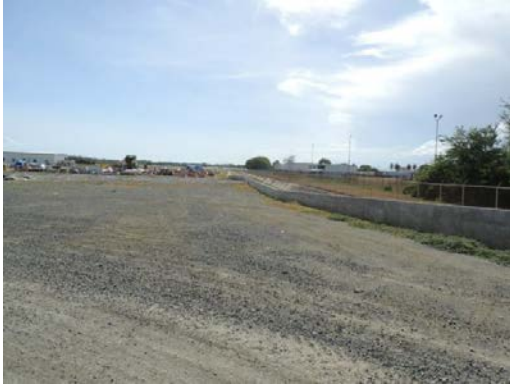
EPA Picture 19

EPA Finding: One of the warehouses in plant yards was undergoing cleaning. AES was storing equipment and materials exposed to precipitation without storm resisting coverings. (See EPA Picture 19)

AESPR Response: AESPR disputes the alleged violation as the exposed equipment and materials did not contain any uncovered cleaning materials or similar materials that would pose a risk if added to storm water. The items identified in EPA's Inspection Report were covered with storm-resistant coverings and then returned to storage as soon as the warehouse cleaning work was completed. (ASEPR After Picture 19). In addition, AESPR has implemented the following measures:

- Revised the Storm Water Pollution Prevention Plan (SWPPP) to include specific provisions in the Exposure Minimization section to address material storage. *See* SWPPP at page 13
- Provide and document training to all employees and required contractors about these exposure minimization requirements.
- During the Routine Facility Inspection, *see* SWPPP at page 22\_\_, all site areas will be inspected for material and equipment that are exposed and may require cover, *see* SWPPP at Worksheet #5 .
- Have available at the plant storm-resistant covering in case equipment or materials may be exposed to a storm event.

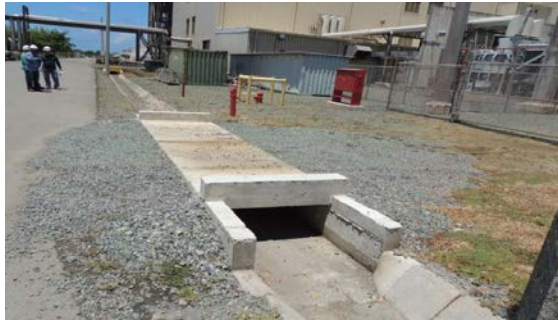
EPA Picture 9

EPA Finding b.(1): The storm water concrete swale located on the west area of the Site (near the electrical grid) was observed with sediment and gravel accumulation and lacking good housekeeping. (EPA Picture 9).

AESPR Response to EPA Finding b.(1): AESPR addressed the housekeeping in the noted area by removing the limited gravel in the swale. (AESPR After Picture 9). AESPR disputes this was a violation. Moreover, the gravel present alongside the swale (AESPR Picture 9) does not represent poor housekeeping, but is situated there to provide truck access to the opposite side of the channel. Nevertheless, to address the EPA's concern, each concrete swale was assigned an AESPR "area owner" who is responsible to inspect, maintain and clean the swale at least once per month or before an expected storm. AESPR has also revised the SWPPP to include a Storm Water Maintenance Matrix. *See* SWPPP at Appendix 1. The Matrix specifies the area owner, describes the specific areas covered and the required tasks, and identifies frequency for each task. These areas will also be inspected during the quarterly Routine Facility Inspection.

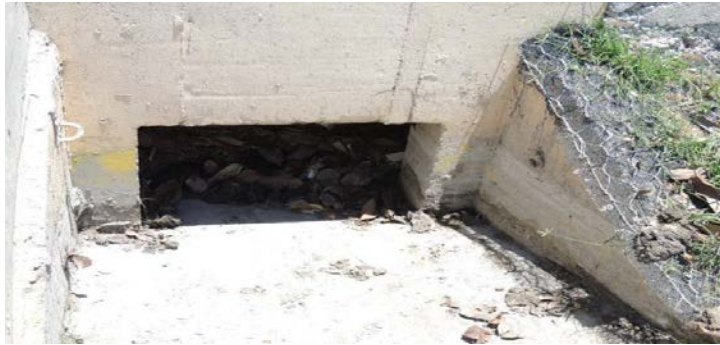
EPA Picture 10

EPA Finding b.(2): The storm water concrete culvert located beneath the fly ash loading area was found with debris, sediment, and ash, and lacked maintenance. (EPA Picture 10).

AESPR Response to EPA Finding b.(2). EPA addressed the specific area identified in EPA's Inspection Report. (AESPR After Picture 10). In addition, the SWPPP was revised to include concrete culverts and swales in the Housekeeping Section, with all concrete culvert sections now specifically included the facility's Storm Water Maintenance Matrix to assure regular housekeeping. SWPPP at Appendix 1. Further, these culverts will now be inspected during the Quarterly Routine Facility Inspection.

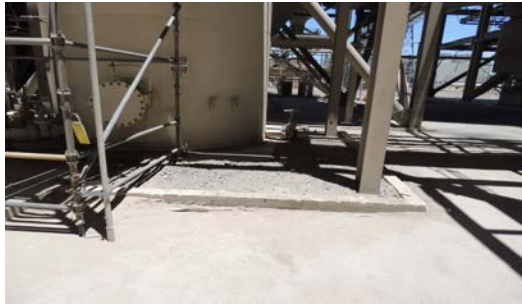
EPA Picture 11

EPA Finding c.(1): EPA observed crushed stone construction residues inside a containment area (CDS/ESP) reducing capacity. (EPA Picture 11).

AESPR Response to EPA Finding c. (1): All crushed stone construction residues were removed and a concrete slab was constructed inside the CDS/ESP containment area. (AESPR After Picture 11). These containment areas are equipped with process water drains to avoid any contaminated water from reaching the storm water conveyance system. The process water drains flow to the oil and water separator in the cooling tower make up water pond.

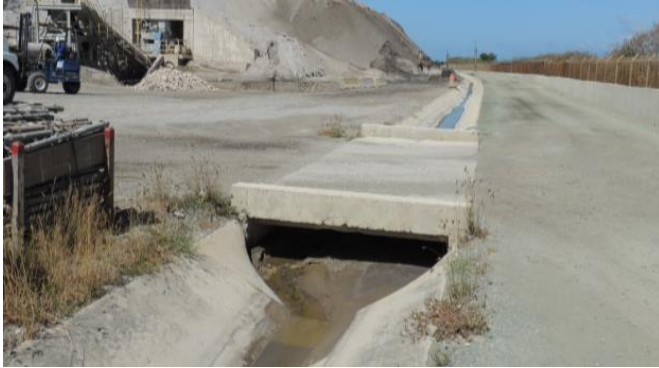
EPA Picture 12

EPA Finding c.(2): The concrete swale along the Agremax™ pile and coal piles areas were observed with gravel, dust, Agremax™, and coal, and lacked housekeeping. (EPA Pictures 12-14). (Picture 14 showed a PVC pipe that the Report asserted was an illegal connection carrying process wastewater into the Storm Water Runoff Pond.)

AESPR Response to EPA Finding c.(2): AESPR disputes the assertion that Agremax was present in the observed areas. However, the materials observed during the Inspection were addressed. The observed PVC piping has been capped (EPA Picture 13, AESPR After Picture 13) (EPA Picture 14, AESPR After Picture 14). Further, to address the EPA's concern, all concrete swales along the Agremax and coal pile areas were assigned an AESPR staff owner responsible for proper housekeeping of the area and to maintain and clean it at least once per month or before an expected storm. AESPR also revised its SWPPP to include a Storm Water Maintenance Matrix to specify the area owner, describe the specific area to be addressed, and identify the frequency for each task. Each of these areas is also included in the Quarterly Routine Facility Inspection to better ensure continuous compliance with this responsibility.

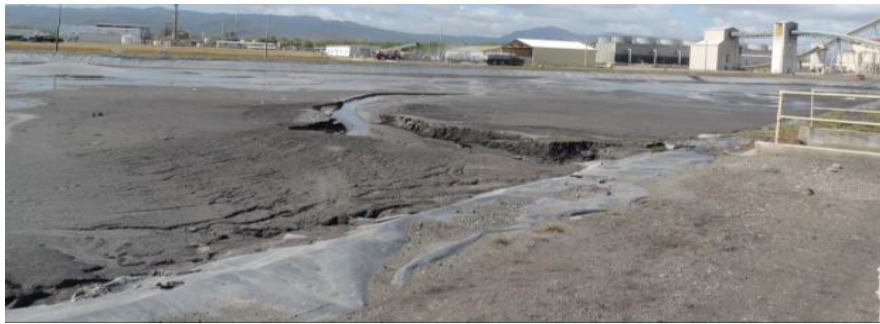
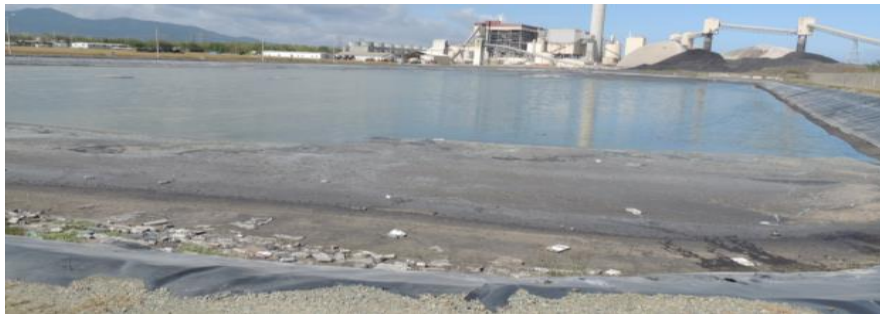
EPA Finding c.(3): AES was in the process of emptying the Coal Pile Pond for cleaning and repair, which is a required maintenance activity to eliminate overflow discharges of storm water and process wastewater into wetlands through outfall 003: AES has failed to complete this task since it was found during the July 2011 CEI. (EPA Pictures 15-16).

one of only a few located in Puerto Rico that the company believed had the experience and capabilities to perform this job. Regardless, the Coal Pile Runoff Pond cleaning was finished on December 31, 2014. This activity was an extensive undertaking that included the following:

- Removal of all water then contained in the pond.
- Removal of all sediment from the pond. The sediment was composed of ash and coal residue and was stored at the inactive coal pile for boiler consumption in combination with coal.
- Removal and disposal of the damaged liner sections.
- Soil preparation where the liner was removed.
- Installation of new liner sections.
- Pin holes repair and sediment traps cleaning.

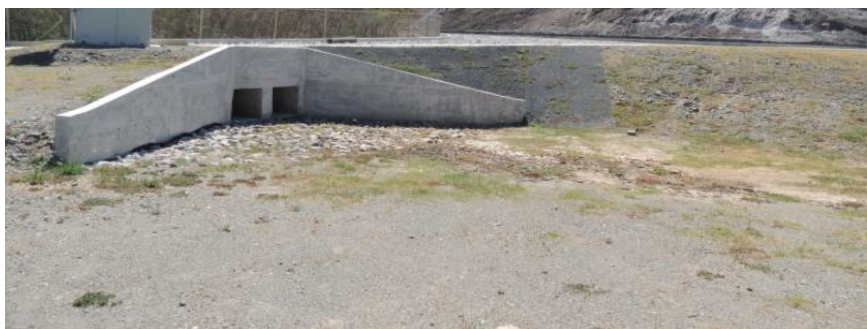
EPA Picture 17

EPA Finding d.(1): There was exposed soil without adequate stabilization within the southeast corner of the Site, near the concrete culvert that discharges through outfall 002. (EPA Picture 17).

AESPR Response to Finding d.(1): The area identified in the Inspection Report (in the southeast corner of the Site, near the concrete culvert that discharges through outfall 002) was seeded to improve vegetation growth (AESPR Picture 17). In addition, the maintenance of this area is included in the landscaping maintenance contract.

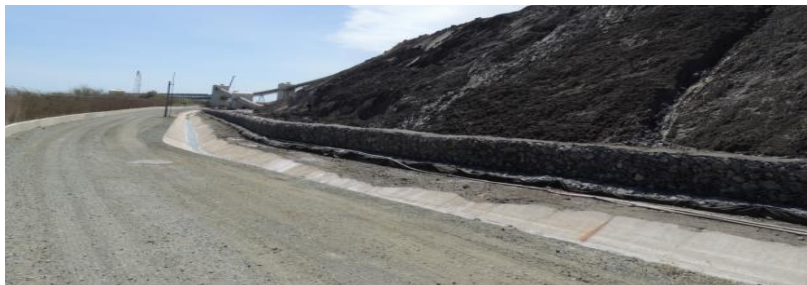
EPA Picture 18

EPA Finding d. (2): The dirt road that borders the south boundary of the Site was found without adequate soil stabilization. Traffic on this road was causing excessive fugitive dust emission into the air and adjacent wetlands fallout. (EPA Picture 18).

AESPR Response to Finding (2): AESPR disputes that the dirt road was not stabilized sufficiently or was causing excessive fugitive dust into the air or adjacent wetlands. However, the dirt road identified in the Inspection Report has been further stabilized with gravel. (AESPR After Picture 18). In fact, AESPR has enhanced the stabilization of site unpaved roads and unpaved areas with a gravel application. Further, an area owner among AESPR staff has been who is responsible for ensuring these areas are well-maintained and continue to be stabilized properly, as reflected in the Storm Water Maintenance Matrix, which is part of the SWPPP. In addition, during the quarterly Routine Facility Inspection, AESPR will inspect the roads to assess and identify any locations where maintenance is required.

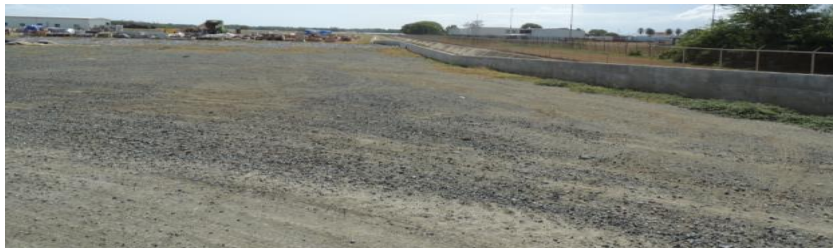
EPA Picture 19

EPA Finding d.(3): Several plant yards were observed with inadequate soil stabilization. For example, the yards between the cooling tower and maintenance shop building were found in such condition. (EPA Picture 19).

AESPR Response to EPA Finding d.(3): AESPR disputes that the plant yards lacked adequate stabilization. However, the yards between the cooling tower and maintenance shop building identified in the Inspection Report are now further stabilized with gravel (AESPR After Picture 19). In addition, as noted AESPR has stabilized all site unpaved roads and unpaved areas with a gravel cover. Further, an area owner among AESPR staff have been designated as responsible for ensuring these areas are well-maintained and continue to be stabilized properly, as reflected in the Storm Water Maintenance Matrix, which is part of the SWPPP. In addition, during the quarterly Routine Facility Inspection, AESPR will inspect the roads to assess and identify any locations where maintenance is required.

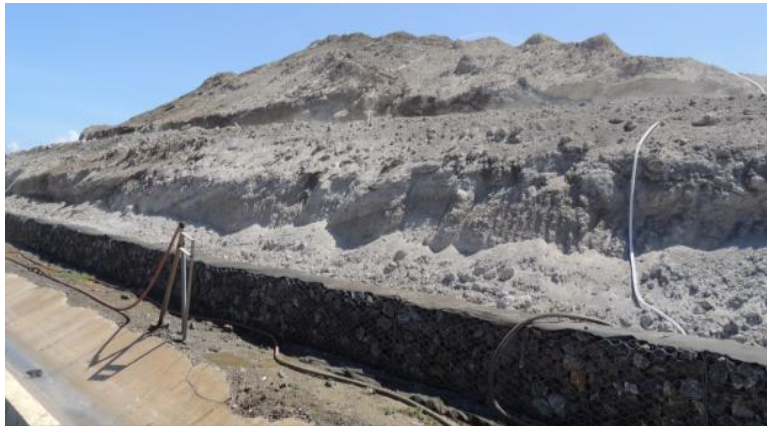
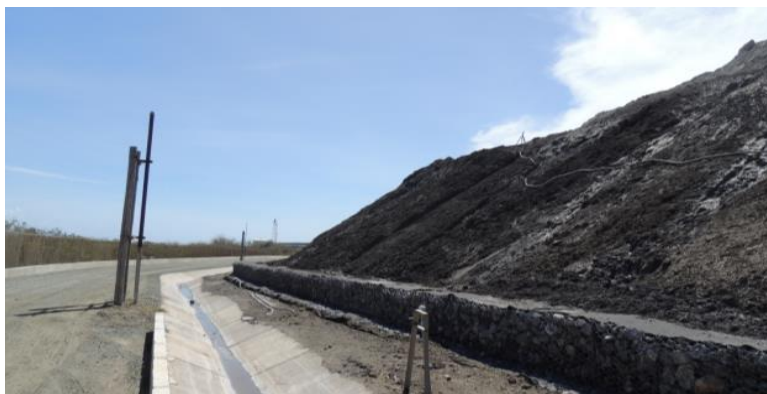
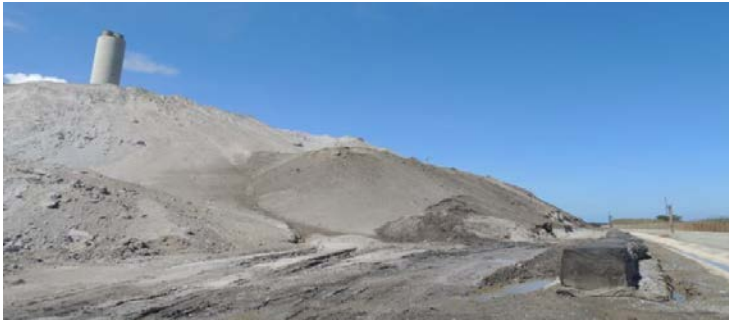
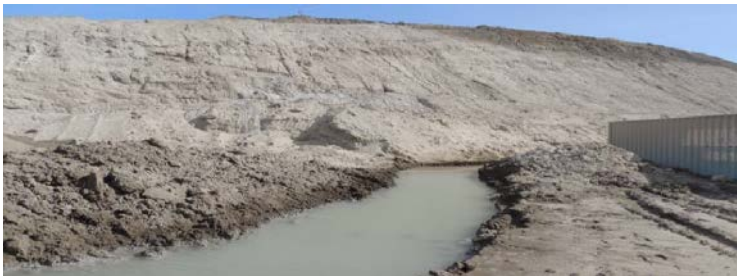
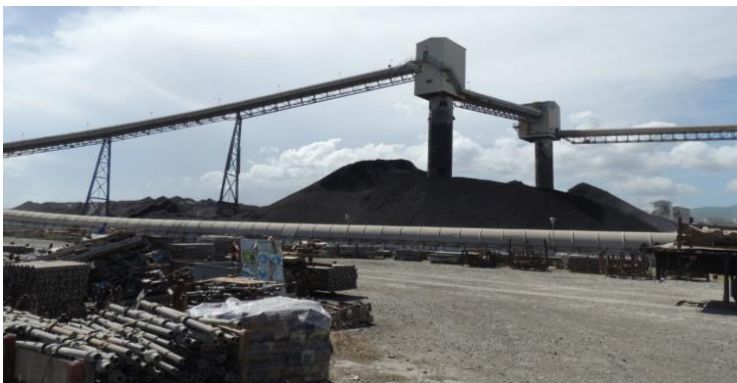
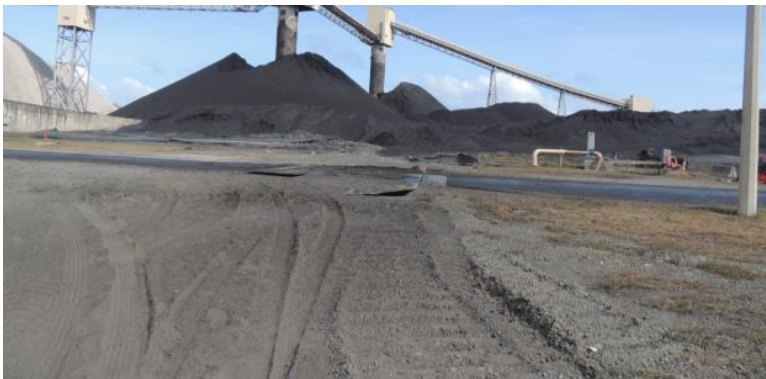
EPA Finding d.(4): Slope stabilization and storm water management are not provided in the Agremax storage pile and in some slopes of the coal storage piles. (EPA Pictures 20-25).

AESPR Response to EPA Finding d.(4): AESPR disputes that stormwater management has not been provided for the inventory of Agremax stored at the AESPR property or at the coal storage pile. The facility has implemented an extensive stormwater management program to collect and route all stormwater run-off to the coal storage runoff pond. The Agremax pile and the coal pile are considered active. Their area, volume and form change over time make it difficult to establish a permanent slope. However, AESPR has taken and is taking steps to address the EPA's concerns about the controls surrounding the Agremax inventory, to reduce run-off and if there is run-off, to collect and route run-off to the coal storage run-off pond.

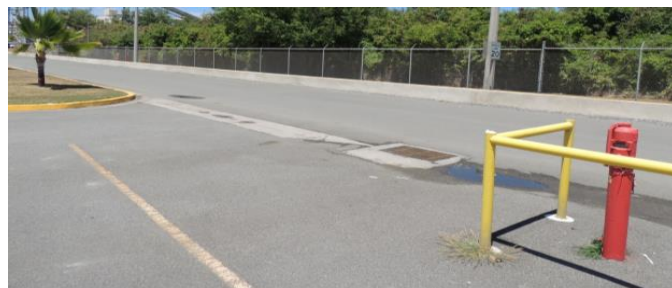
EPA Picture 26

EPA Finding d. (1): Certain storm water inlets did not have inlet protection. (EPA Picture 26).

AESPR Response to Finding e. (1): The drain identified in the Inspection Report is located near the administrative building, not in the process area. All inlet catch basin drains within process areas are protected with drain guards. (For example, AESPR After Picture 26). The drain guards are inspected and replaced frequently as required by the Storm Water Maintenance Matrix, which, as noted, is incorporated into the facility SWPPP. An area owner who is responsible for inspecting and replacing drain guards as needed has been assigned. The drains are also inspected Quarterly as part of the Routine Facility Inspection .

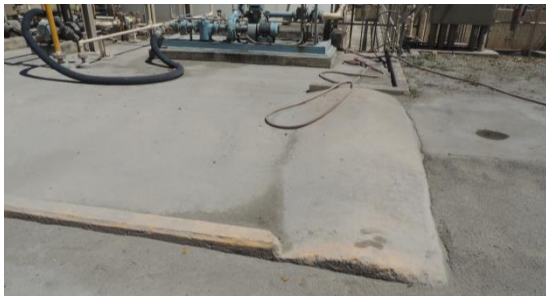
EPA Picture 27

EPA Finding e. (2): One (1) corner of the concrete low wall secondary containment located near the diesel unloading area was broken. (Picture 27).

AESPR Response to EPA Finding e.(2): The broken corner of the low wall at the secondary containment located at the diesel unloading areas was repaired. (AESPR After Picture 27).

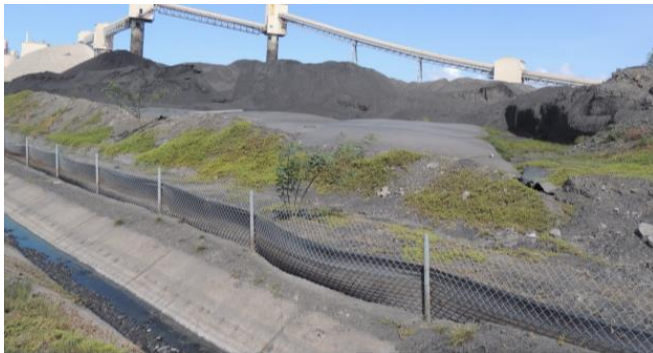
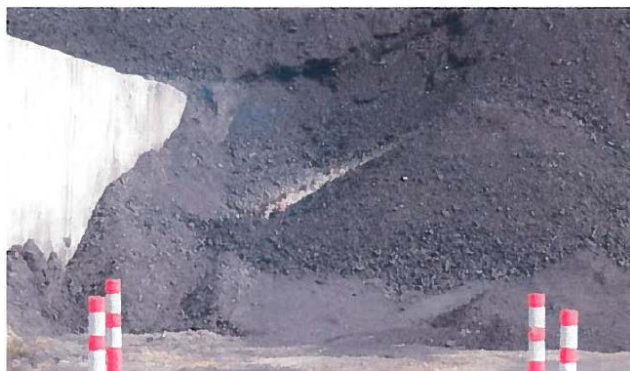
EPA Finding e.(3): AES has not replaced and/or installed silt fence at the perimeter of the coal storage piles and coal handling areas. (Picture 27).

AESPR Response to EPA Finding e.(3): AESPR disputes that the silt fence was not sufficient to manage the coal storage piles and coal handling areas, as the silt fence was in

very good condition in significant areas surrounding the perimeter of the coal storage piles and the coal handling areas. To address EPA's concerns, AESPR has replaced the silt fence in locations along the inactive coal pile. In addition, the requirement to inspect and if necessary repair or replace sections of the silt fence has been included in the Storm Water Maintenance Matrix, which is part of the facility SWPPP. As such, an area owner has been assigned who is responsible to maintain this BMP. Moreover, this area is also inspected as part of the Routine Facility Inspection to evaluate this BMP and ensure corrective measures are taken, if necessary.

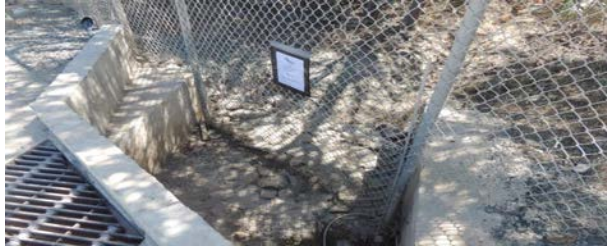
EPA Finding f. (4): Off-site tracking of what appears to be Aggremax™ fine particles was observed at the wetlands (outfall 002). Picture 29 depicts this finding.

AESPR Response to EPA Finding f.(4) – AESPR disputes the assertion that Agremax particles were present at the wetlands or that Picture 29 depicted the presence of such particles. It is AESPR's view that what was observed was dirt.

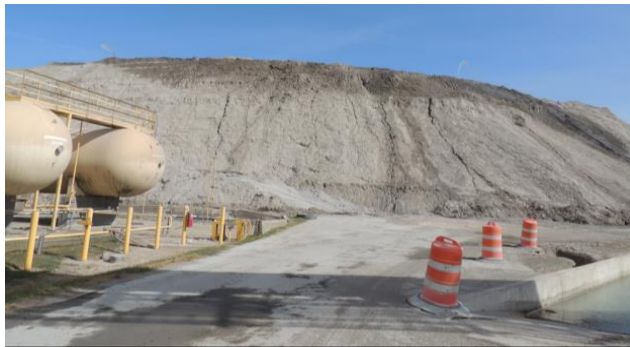
EPA Picture 30

EPA Finding g.(3): AES lacks an adequate and effective dust control system for the Agremax storage pile. Although hoses were feeding water to several sprinklers located on the top side areas of the slopes, most of the slopes were dry and emitting fugitive dust caused by wind. (EPA Picture 30).

AESPR Response to EPA Finding g.(3): AESPR disputes that it lacked an adequate or effective dust control system for its Agremax inventory. However, in response to EPA, AESPR has completed a significant capital project which includes the installation of a new pump with substantially greater capacity to provide water, a new HPVC distribution header pipe, and eight (8) new sprinkler connections (for a total of nine sprinklers). This upgraded system will enhance water sprinkler distribution to provide improved dust control coverage at the Agremax inventory.

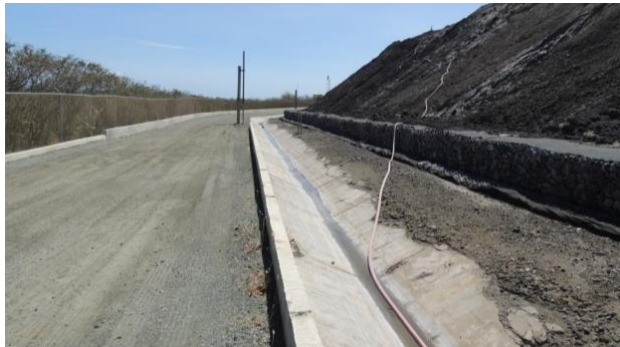
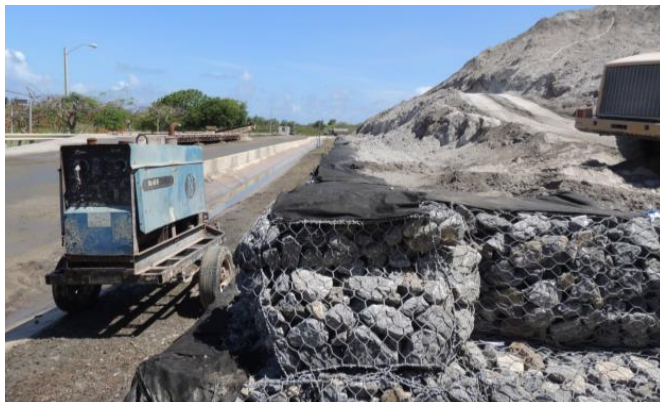
EPA Finding h.(1): Certain slope bottoms of the Agremax™ storage pile were observed on top of the gabion BMP structure, precluding this designed BMP (and its attached silt fence) from functioning. EPA also observed AESPR personnel using mechanical equipment to remove Agremax™ away from the gabions to allow space for the required buffer area. (Pictures 31-32).

AESPR Response to EPA Finding h.(1): AESPR disputes that the presence of observed Agremax precluded the function of this BMP. However, AESPR has addressed the slope bottoms observed on the BMP structure. (AESPR After Pictures 31-32). A buffer zone (of up to 10 feet) has been established between the Agremax storage pile and the gabions wall in order to ensure the storm water filtering system in this BMP is able to function fully. As the pile is actively being used, the slope bottoms will adjust, but the buffer zone will be maintained through routine inspections. The need for the buffer zone is now included in the Storm Water Maintenance Matrix and an area owner has been assigned to inspect and maintain this requirement. The presence of a buffer zone will also be inspected during the Quarterly Routine Facility Inspection.

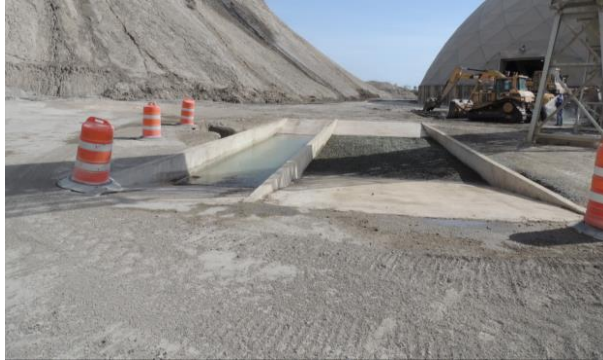
EPA Picture 33

EPA Finding i.(1): AES constructed a structural BMP between the Agremax™ storage pile and the limestone storage dome to reduce tracking of sediments into roads at the plant. EPA found the construction of the structural BMP was adequate but the exit path to the road lack soil stabilization control. (EPA Picture 33).

AESPR Response to EPA Finding i.(1): AESPR disputes that the exit path lacked sufficient stabilization. However, to address EPA's observation, the exit path of the

wheel washer BMP was further stabilized with gravel. (AESPR After Picture 33). In addition, the area is on the Storm Water Maintenance Matrix and will be maintained by assigned plant staff.

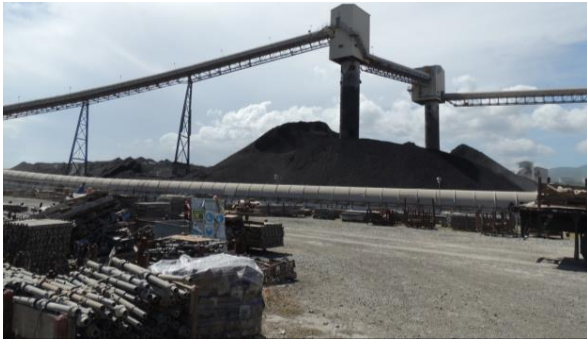
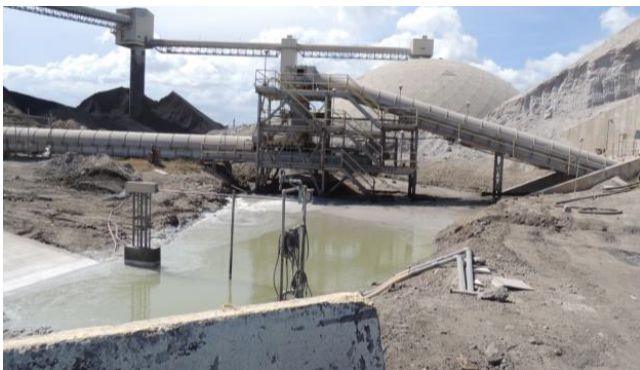
EPA Finding i.(2): The plant yards behind the south side of the limestone storage dome were observed without soil stabilization. Also, the process wastewater basin located in this area was not constructed following best engineering practices to allow for adequate sedimentation and slope stabilization. (EPA Pictures 34-35).

AESPR Response to EPA Finding i.(2): AESPR disputes the plant yards behind the south side of storage dome lacked sufficient soil stabilization. However, all site unpaved roads and unpaved areas have been stabilized further with a gravel cover. (AESPR After Picture 34). Further, AESPR disputes that there is any current compliance issue with the wastewater basin warranting further action by AESPR, as the basin is sufficient to manage storm water as needed at this area of the facility; the original design foresaw that any water collected in this area would transferred to the coal pile water run off collection pond, which is and has been occurring. In addition, an area owner has been assigned to maintain these areas to ensure they continue to be properly stabilized. This is included in the Storm Water Maintenance Matrix which is part of the SWPPP. Further, these areas will be inspected as part of the Quarterly Routine Facility Inspections.

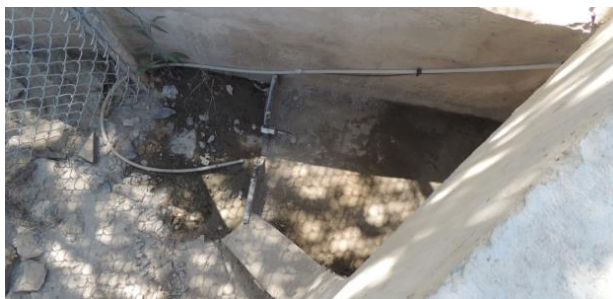
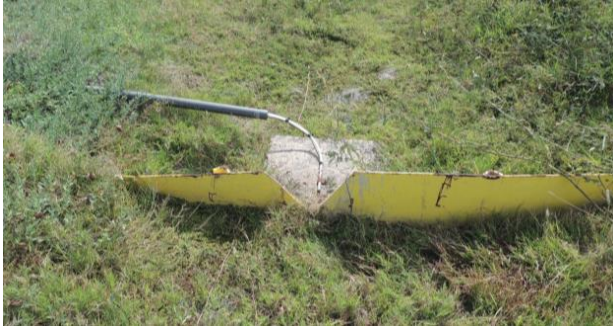
EPA Finding j.(1): AES installed two V-notch weirs to provide for a free and unobstructed flow when sampling the storm water discharges associated with industrial activity through outfalls 002 and 003. AES also installed two solar-powered automatic samplers for sampling points 002 and 003. However, the tip of the samplers tubing was observed touching the surface; and therefore, the sample tubing were not installed properly. Also, the bottom of the V-notch weir crests was touching the surface. (EPA Pictures 36-37).

AESPR Response to EPA Finding j.(1): Outfall 002 has been reconstructed. (AESPR After Picture 36). The tip of the samplers tubing's from SP-002 and SP-003 was modified to avoid contact with the channel inlet. The bottom of the v-notch weirs have been re-installed above the channel inlet. (AESPR After Picture 37).

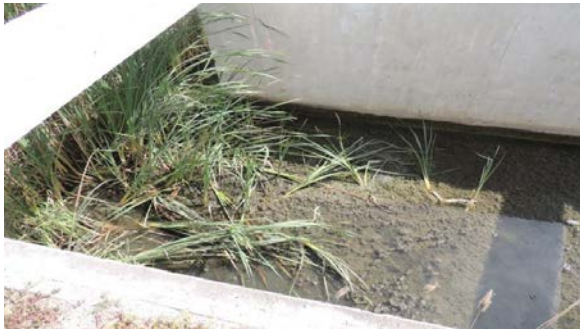
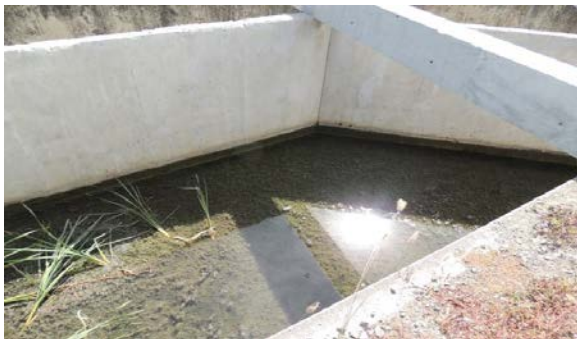
EPA Finding j.(2): EPA observed vegetation growth and lack of maintenance along the concrete channel that discharges through Outfall 003. This is causing backflow and algae growth. (EPA Pictures 38-39).

AESPR Response to EPA Finding j (2): AESPR disputes that the channel was not reasonably maintained, given its location and the Puerto Rico climate. Regardless, the observed vegetation was removed and additional maintenance has been conducted along the concrete channel that discharges through Outfall 003. In addition, this area is covered by the Storm Water Maintenance Matrix, which is part of the facility SWPPP, and the Quarterly Routine Facility Inspections.
